MEMORANDUM

To: The Design Advisory Board
From: Mary O'Neil, AICP, Principal Planner
RE: ZP21-639; 48-50 Greene Street
Date: September 14, 2021

File: ZP21-639
Location: 48-50 Greene Street
Zone: RM **Ward:** 2C
Parking District: Neighborhood
Date application accepted: August 31, 2021
Applicant/ Owner: Lee Bissonette
Request: "Repair of Fire Escape"
Site visit: September 8, 2021

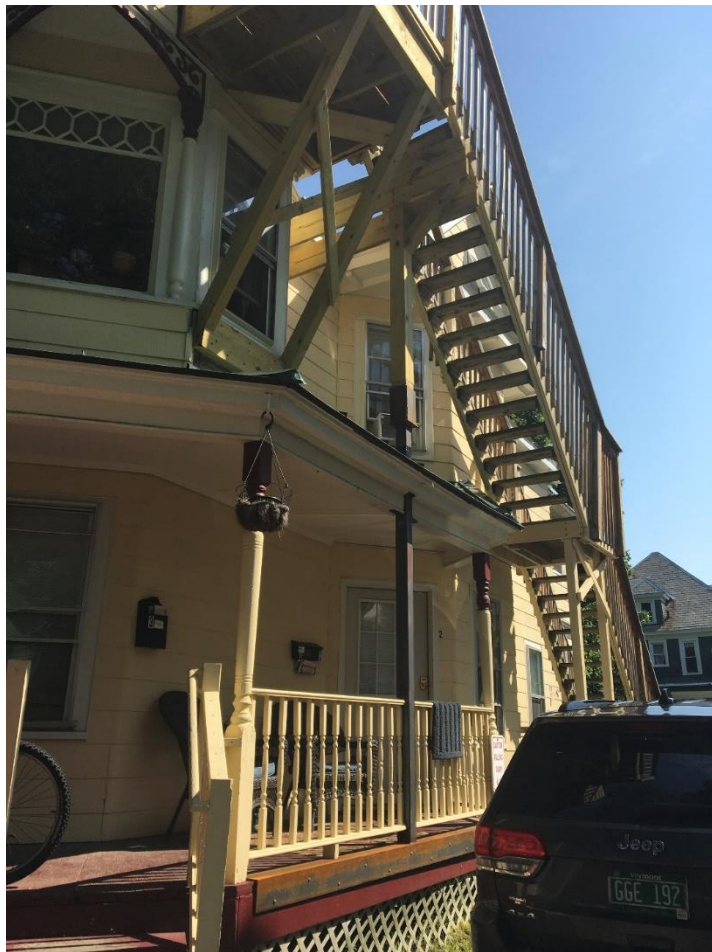
There are no identified natural features within the application. The replacement stairs have been constructed in the same location as the 1984 stairway.

The application is an after-the-fact permit to “repair” an exterior stair originally erected in 1984. The design of the stair, which rises from the ground level to the third story has been altered by the addition of a support column between the first floor porch and the third floor landing. The contractor has carried the weight of the upper deck landing down onto an iron plinth, mounted through the

The egress stair replaces another installed in 1984. In that manner, the visually intrusion is similar. The earlier stair did not have the additional porch support which is obtrusive and especially visible from the public right-of-way.

Providing additional support by introducing non-historic materials on a façade visible from the street is a physical treatment that mars the historic character of the structure. Piercing the first floor porch roof for the iron column is a physical treatment that has caused damage to historic building fabric, and portends additional damage with exposure to the elements.

The stair replacement introduces non-historic building fabric that diminishes the historic integrity of the structure. A common resolution to achieve building and life safety code for multi-story, multi-unit structures is to sprinkle the building; a much preferred solution than the one under review.

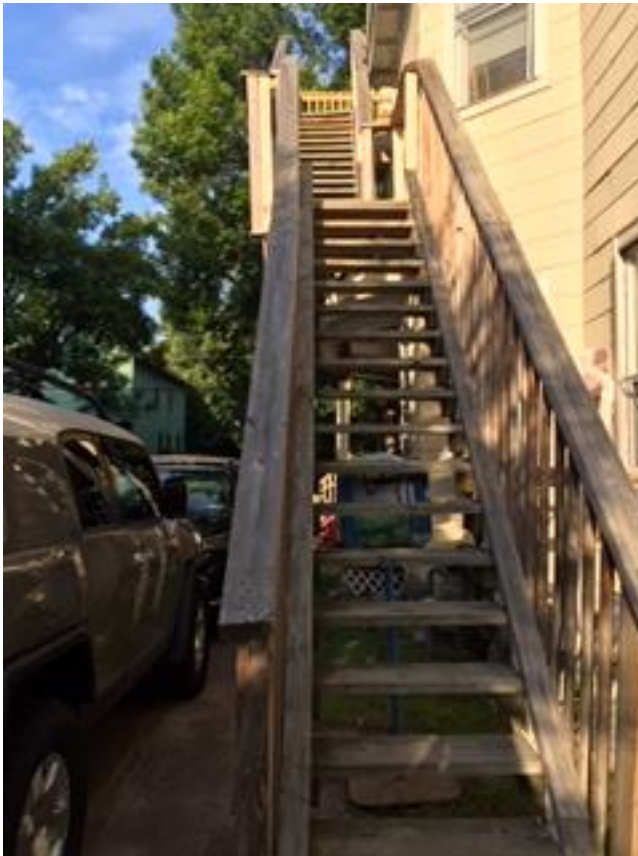
The top of the landing has no canopy, other than the roof eave. The stair, itself, is uncovered. Building code typically requires that egress stairs be covered if the steps are wooden and the building is not occupied by an owner, who could attend to ice and snow.

Current building code may require a roof cover over the stairs if the building owner does not live at the dwelling. No roof cover was included in this reconstruction.

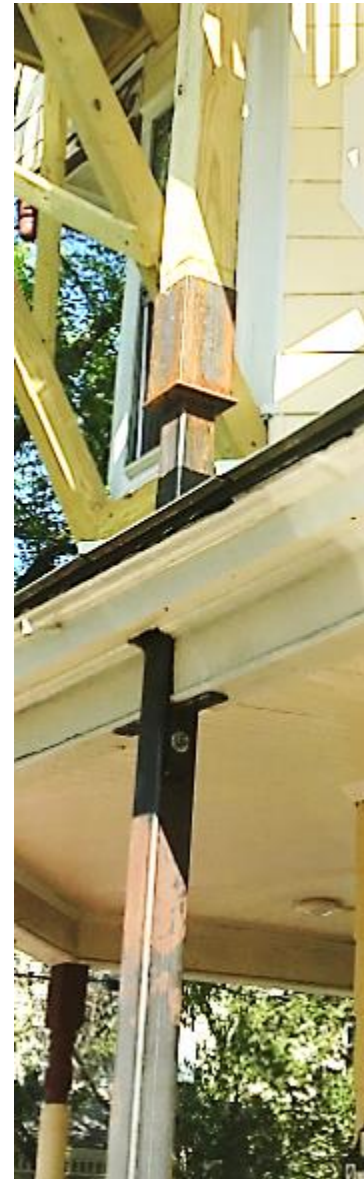
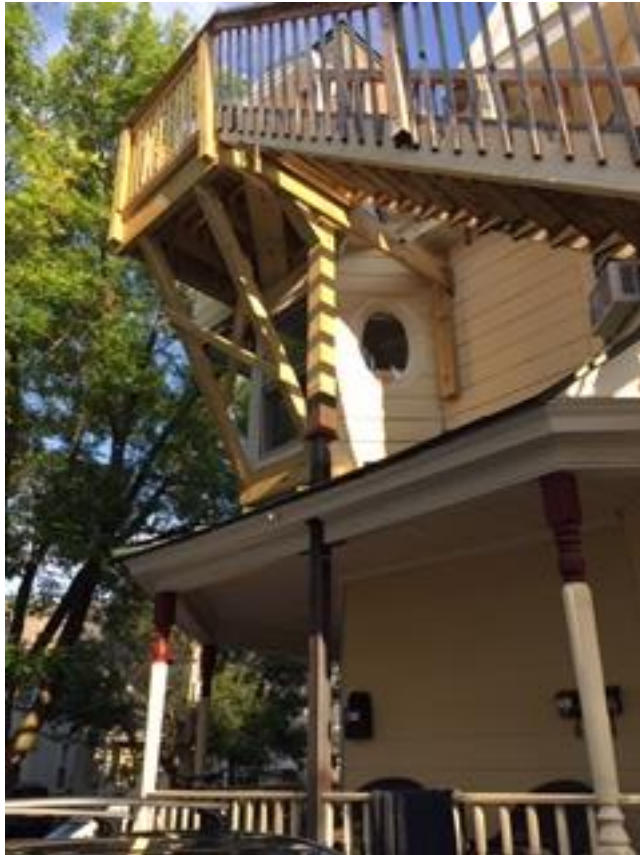
The piercing of the porch roof introduces an opening in the building envelope that will

invite water and early rot. The solution was ill-advised from the standpoint of building care and protecting the character defining features of the building.

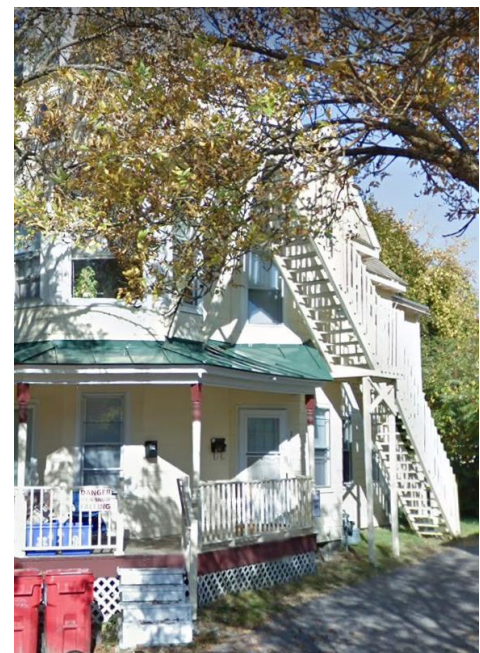
The stairs themselves appear to be in the same location as the previous stairs; but the iron support pole that rises vertically through the first floor porch roof is a visual intrusion that is particularly damaging to the porch and to the integrity of the historic structure.
